Manhole Inspection Summary

Manhole # S23E1_002MH

Location Address: **Hollins Ferry Rd.**

Cross Street: **Waterview Av.**

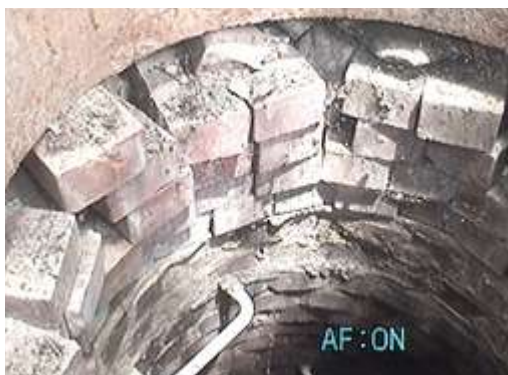
Defect 2

Condition: ☐ Sound ☐ Cracked ☐ Root Intrusion ☒ **Loose Brick** ☒ **Deteriorated**

Infiltration: ☐ None ☐ Joint ☐ Cracks ☒ **Mortar** ☐ Roots ☐ Wall

Loose bricks at chimney with missing mortar & signs of flow

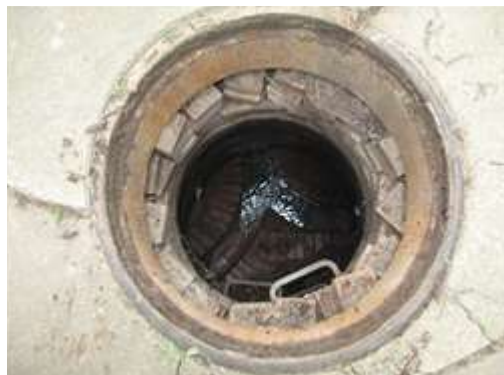
Defect 3

deteriorating chimney

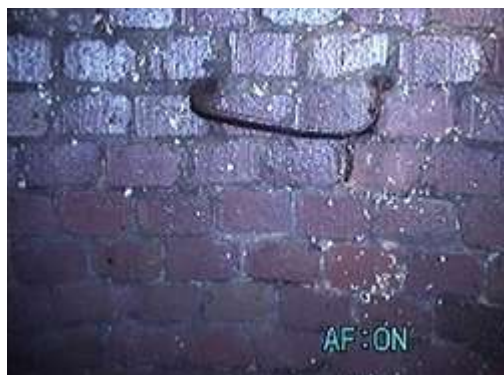
Defect 1

Count: **4** Missing: **0** ☒ **Corroded**

Corroded step
